## Test Report

Order : Test of the water-tightness of a concreted in coated liner pipe ZVR DN 100 with annulus gasket HRD 100

Kiwa MPA Bautest GmbH received an order from Hauff-Technik GmbH & Co. KG to perform a water leak test on a concreted-in coated liner pipe ZVR DN 100 with annulus gasket HRD 100.

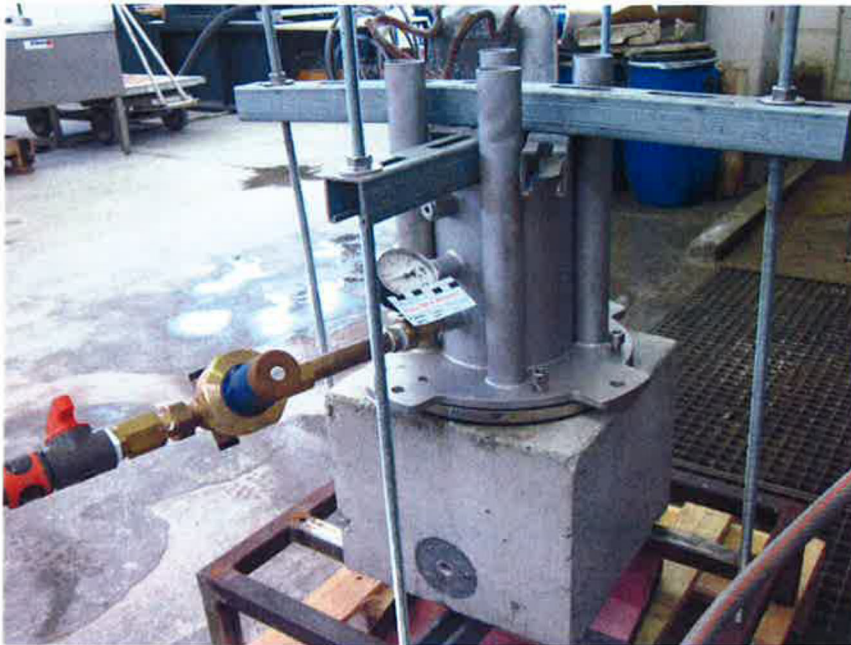
To this end, Hauff-Technik GmbH & Co. KG delivered a ready-assembled test setup with a concreted-in coated liner pipe ZVR DN 100 with annulus seal HRD 100 to our laboratory in Augsburg (see Figure 1). The test bell was secured by the client using square steel sections.

Figure 1: Test setup

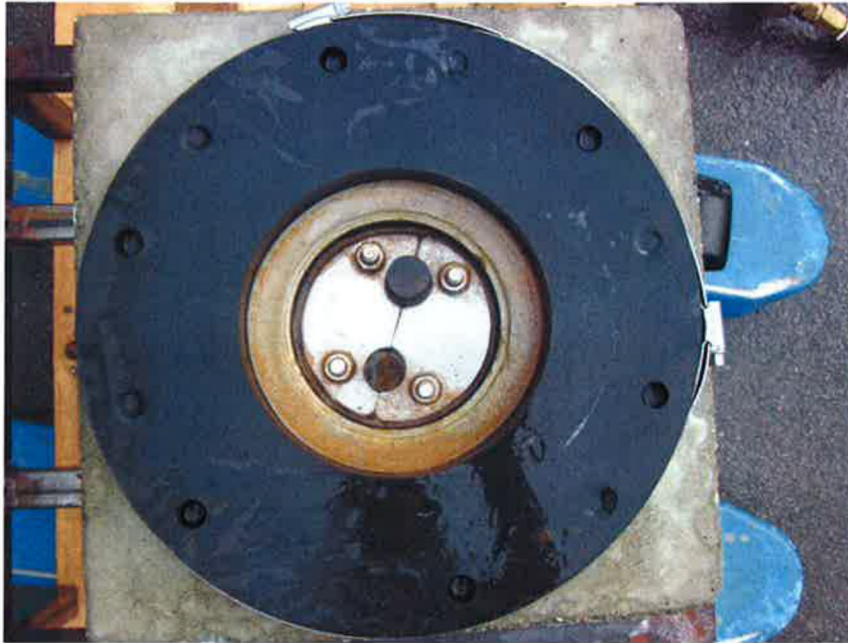
Figure 3: View - top of the test setup (after removing the test pressure bell)

The test body delivered by Hauff-Technik GmbH & Co. KG is a test setup assembled by the manufacturer according to 2.1 with pre-installed pressure gauge and pressure reducer (see Figure 2 to Figure 5). Kiwa MPA Bautest GmbH did not calibrate the pressure gauge delivered in the test setup.

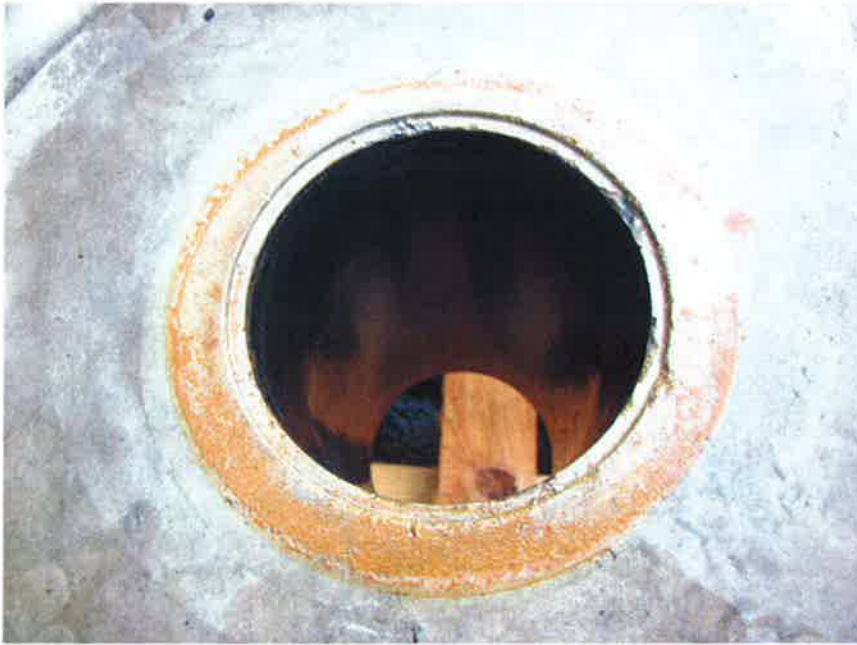
Figure 5: View - top of the test setup; concreted-in coated liner pipe ZVR DN 100

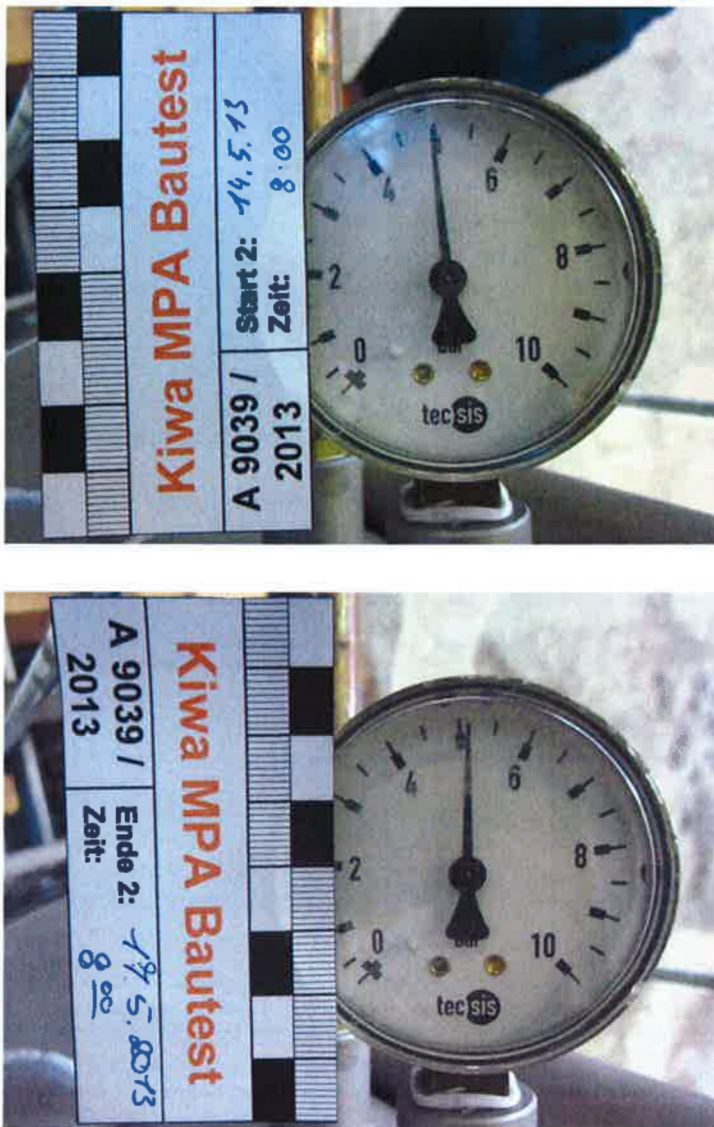
The following Figure 6 shows the pressure gauge readings at the start and end of the pressure leak test.

Figure 6: Pressure leak test with the water-filled pressure bell at room temperature (top: Pressure gauge reading at start of the test on 05/14/2013 at 08:00; bottom: Pressure gauge reading following the end of the test on 05/17/2013 at 08:00)

Following consultation with the client a pressure leak test was carried out on the water-filled pressure bell for 72 hours with a permanently connected nominal pressure of 5 bar at room temperature.

*The pressure leak test of the coated liner pipe ZVR DN 100 with annulus gasket HRD 100 and with the water-filled pressure bell performed with a permanently connected nominal water pressure of 5 bar for a test period of 72 hours did not find any leaks in the system in the form of leaking water.*
